(RCA)

**N70-27139**

## PREFACE

This report encompasses all the activities pertaining to Spare Storage Modules 028, 031, and 032 from October 15, 1969 to January 13, 1970. Test data obtained prior to October 15, 1969 are contained in Quarterly Progress Report No. 7, issued October 15, 1969 under NASA Contract NAS 5-10470.

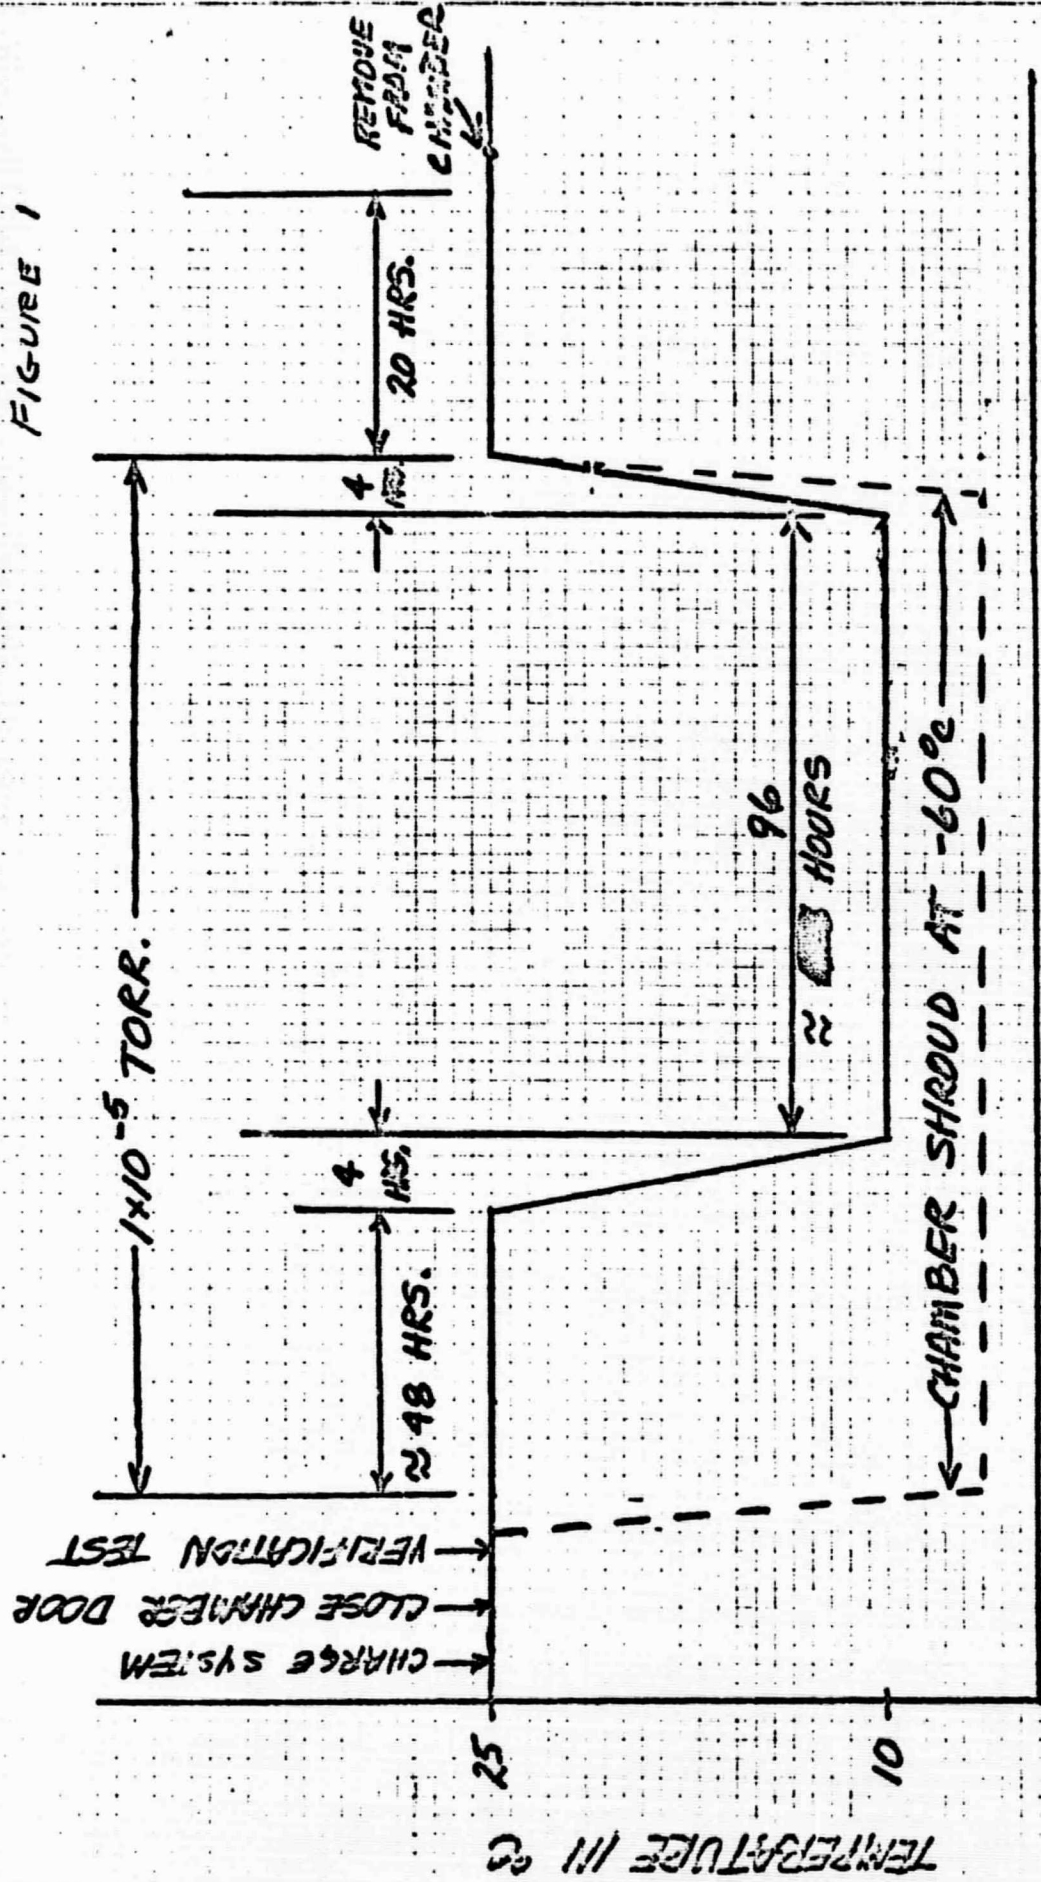
FIGURE 1

The temperature profile shown in Figure 1 was followed. Figures 2 and 3 are histograms of the cell voltages at different times throughout the overcharge test. At the end of the test the spread in cell voltage was small. Two of the highest cells were the replacement cells in both modules. These cells had not been subjected to a complete conditioning cycle prior to assembly in the modules. Figure 4 shows the temperature of each module throughout the test and the voltages of the two highest cells.

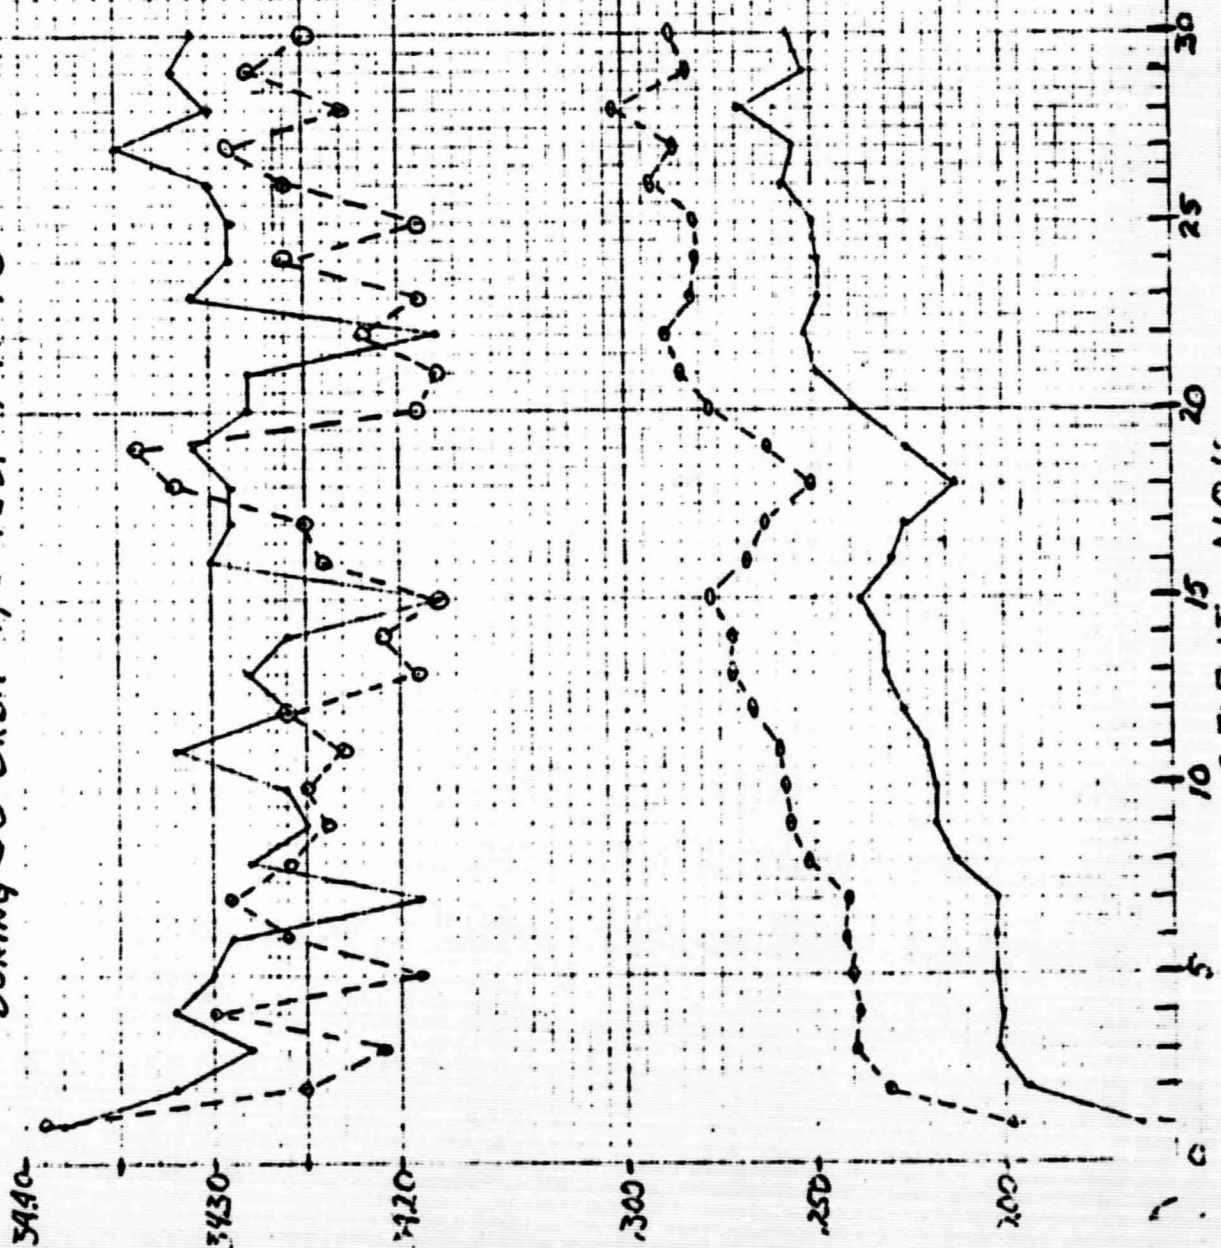
FIGURE 1

Questions have been raised regarding the expected life of spare battery modules 028 and 032 because of an apparent increase in end-of-charge voltages during the 30 cycles run at 10°C. On a module basis there was no increase in voltage as shown in Figure 1. An increase in module voltage is not possible since a temperature compensated voltage limit charge control is used and the charge voltage is limited to a pre-set value. During the cycling the spread in cell end-of-charge voltages increased as shown in Figures 2, 3, and 4. The voltages of some cells increased while others decreased. This spread in end-of-charge voltage is attributed to the increased overcharge at the low temperature.

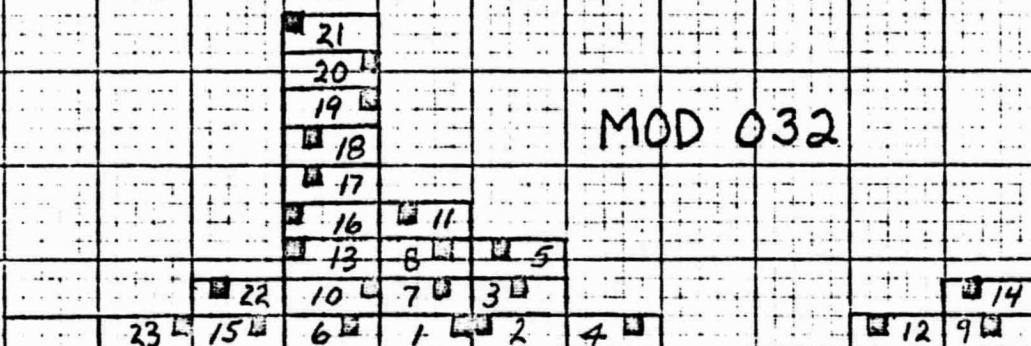
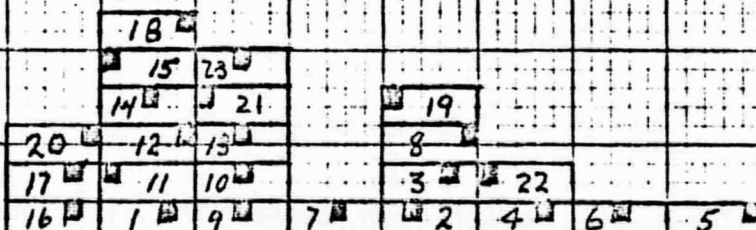
FIGURE 4

Several cells in each module showed consistently higher end-of-charge voltages throughout the cycling. Among these were cells 5 in module 028, 9 and 14 in module 032. These were the replacement cells which were not subjected to the same previous conditioning cycles as the rest of the module.

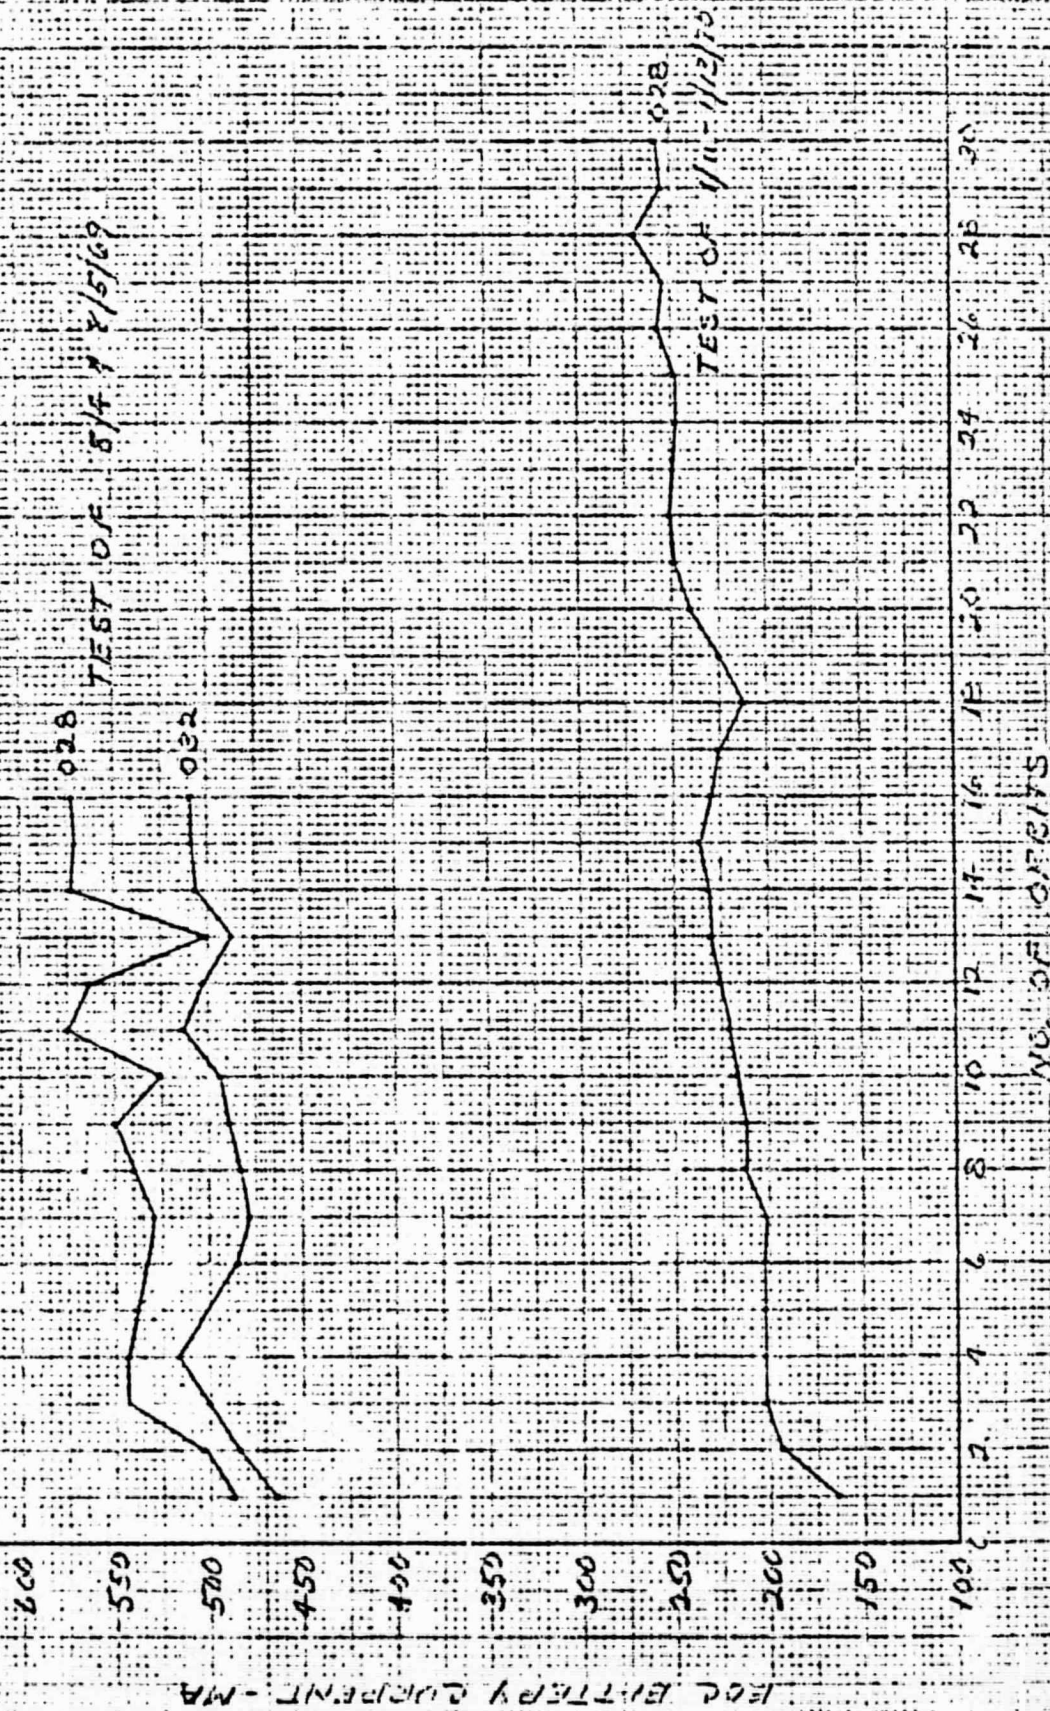
FIGURE 7

Throughout the test the end-of-charge current showed a gradual upward trend. This trend has been seen on other cycling tests and may take several hundred cycles for the cells to equalize and the end-of-charge currents to level off. In a previous 10°C thermal-vacuum test on modules 028 and 032, prior to the overcharge and high surge current stresses, this same trend was observed. Figure 7 shows the end-of-charge currents during the 10°C thermal-vacuum test performed in August 1969. This test followed the standard procedure of TP-SFTV-1846666 in which the charge/discharge ratio was limited to 1.04 by limiting the initial charge current.
